Access Audit

St Michael's Primary School,
Penberthy Road, Helston TR13
8AR

Prepared on Behalf of
Celtic Cross Education (St Austell)

Date: 28th February 2022

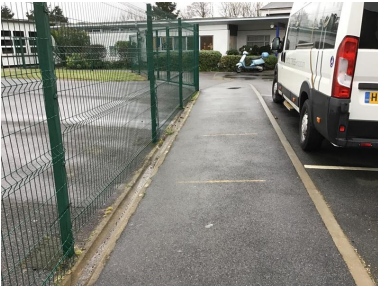
1.1.4	<p>The pathway to the Junior School entrance achieves an adequate width of 1200mm or more, is set to an acceptable gradient and has a firm and level surface.</p>

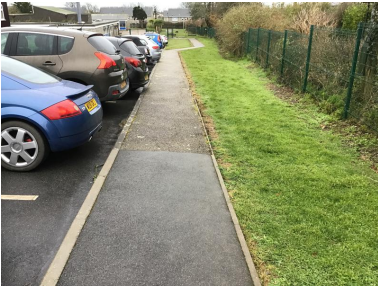
1.1.10	<p>There is no drop off area close to the Infant Building to allow disabled users to be set down.</p> <p>Considering the gradient on the approach, if possible we recommend that a drop off point is created at the entrance gate. This should be fitted with a dropped kerb to allow ease of transfer from carriageway to path.</p>	<p>Create drop off point at Infant entrance</p>	2	A

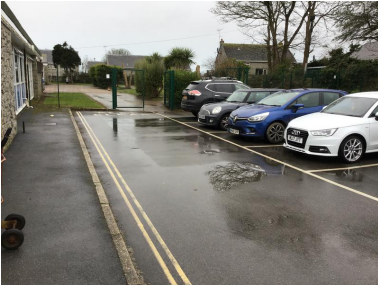
1.1.11	<p>There is no accessible parking next to the Infant School building.</p> <p>A new accessible parking space will help to mitigate the gradient on the approach, allowing disabled users arriving by vehicle to park close to the entrance.</p>	<p>Create 1 new accessible parking bay next to Infant entrance</p>	2	A

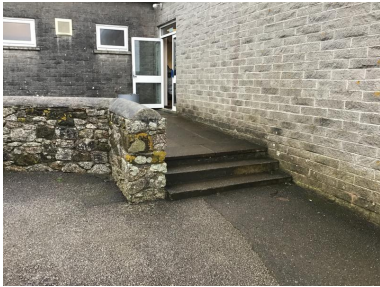
1.1.18	<p>The external steps to the Year 4 classroom have no contrasting nosings and thus it will prove very difficult for a visually impaired user to identify the step edges.</p> <p>Painted nosings will be the most appropriate type in this location.</p>	Apply contrasting nosings to step edges	2	A

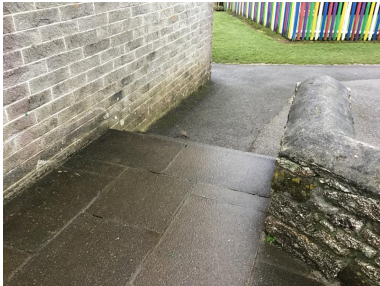
1.1.19	<p>The external steps to Year 4 classroom are not fitted with any handrails and thus there is no means of support for an elderly or mobility impaired person, putting these users at increased risk of accident.</p> <p>Handrails should be fitted to either side to provide a means of support when going up or down to a user with no strength or mobility to one side of the body such as an amputee.</p> <p>New rails should ideally be tubular and between 40-50mm in diameter so that they are easy to grip and should extend a minimum of 300mm beyond the top and bottom steps so they can be gripped before mounting or dismounting the steps.</p> <p>The new rails should also be well</p>	Fit new handrails to either side of steps	2	A

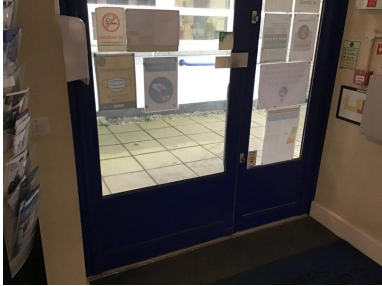
2.1.2	General issues			
	2.1.2.1	<p>The entrance doors require excessive force to pull open of more than 40Newtons, as a result it will prove difficult for a user with impaired upper body strength to open these doors.</p> <p>Best practice recommends a maximum opening force of 30Newtons for the first 30 degrees of the door swing and 22.5Newtons thereafter.</p>	Adjust door closers to achieve maximum 30Newtons opening force	3M	A

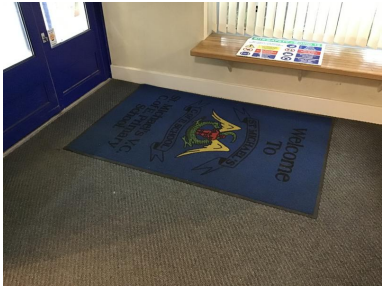
2.1.2.2	The loose mats will pose a trip hazard to all but particularly a visually or mobility impaired person.	Remove loose mats	2	Zero

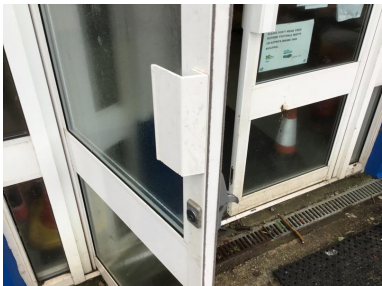
2.1.2.3	<p>The entrance door handles are poorly contrasted against the door frames making them difficult to identify by a visually impaired person.</p> <p>New handles should be of a lever, bar or 'D' handle type and aim to achieve a 30 point difference in light reflectance value with the frame. Knob handles should be avoided.</p>	Fit new well contrasted door handles	3R / 4	A

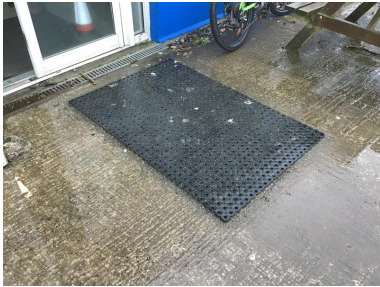
2.1.2.4	The loose mats externally will pose a trip hazard to all but particularly a visually or mobility impaired person.	Remove loose mats	2	Zero

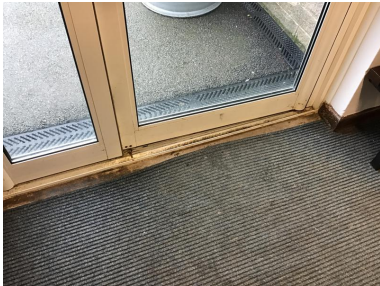
2.1.2.5	Some of the entrance door thresholds have an upstand of around 30mm making it difficult to pass by wheelchair users and posing a trip hazard to mobility and visually impaired users. In this setting this could be addressed by forming timber fillets to either side of the existing threshold to make it easier to 'rollover'.	Fit timber fillets to either side of existing threshold	2	A

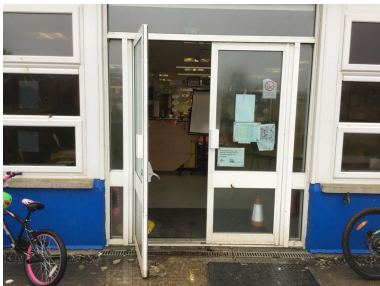
2.1.3.1	The entrance doors achieve a clear width of only 760mm through a single leaf making them difficult to pass by most wheelchair users. Best practice recommends a clear width of 800mm through a single leaf for new entrance doors. As this issue is located in pupil only area	Fit new single or door and a half set to achieve minimum 800mm clear width through a single leaf	3R / 4	B

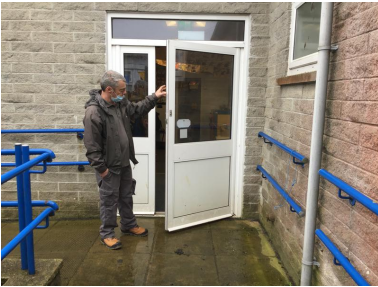
2.1.4.3	The secondary entrance door achieves a clear width of 900mm which exceeds current best practice standards so should be sufficient for all.

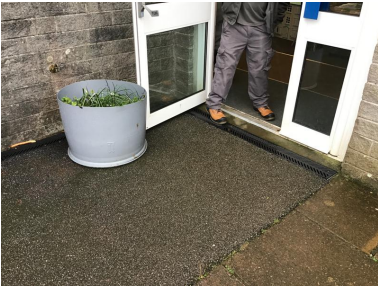
2.1.5.2	The plant pot obstructs manoeuvring space on the approach.	Relocate plant pot	1	Zero

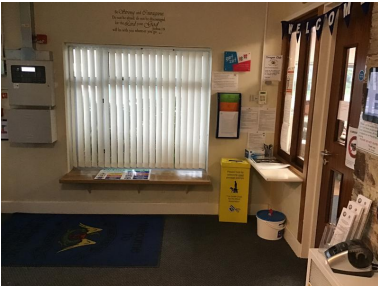
2.2.2	<p>Transitional lighting is poor with lux levels of only 50lux noted.</p> <p>This will result in excessive contrast which can be temporarily disabling to some visually impaired users.</p>	<p>Upgrade transitional lighting to achieve at least 300lux</p>	3R	A

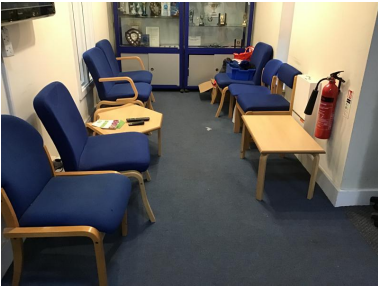
2.2.3	<p>The reception incorporates a waiting area with seating for visitors.</p> <p>There is inadequate clear space for a wheelchair user or ambulant disabled user with mobility aids to sit adjacent to a companion or carer.</p> <p>To comply with best practice, a 900mm wide x 1400mm deep clear space should be maintained.</p>	<p>Adjust the layout of loose furniture to allow a disabled user to sit adjacent to a companion or carer.</p>	1	Zero

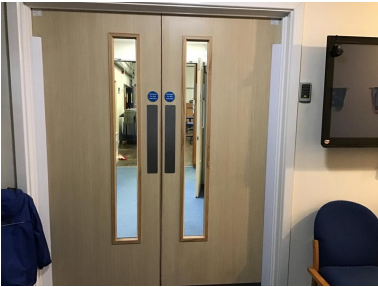
2.4.1.1	<p>The key pads to access controlled doors are fitted around 1700mm above floor level putting it out of reach of most wheelchair users.</p> <p>Best practice recommends that controls are installed within 1000-1200mm of floor level.</p> <p>We see little justification for any adjustments in the short term unless required by a particular member of staff.</p>

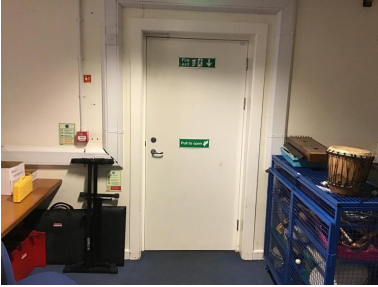
2.4.1.4	<p>A 30 point difference in light reflectance values of adjacent surfaces should be achieved. These values are readily available from paint suppliers.</p> <p>Some internal doors with a painted finish are poorly contrasted against wall surfaces making the openings difficult to identify by a visually impaired person.</p> <p>This can be addressed by painting the walls, architraves or doors in a contrasting colour.</p>	Improve contrast of painted door openings	3R	Zero

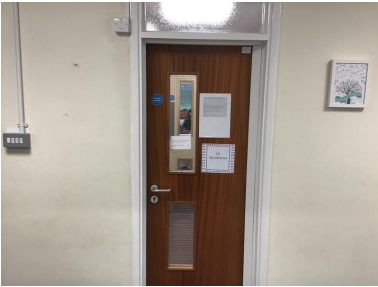
2.4.2	<p>The doors to the support staff office achieve a clear width of only 700mm making them very difficult to pass by the majority of wheelchair users.</p> <p>Best practice now recommends that all internal doors achieve a clear width of at least 800mm. Clear width is measured between door stop and the face of the door when held open.</p> <p>As this issue is located in a staff only area of the building we see little justification for any adjustments in the short term unless required by a particular member of staff.</p> <p>It would only be appropriate to undertake adjustments when a specific need is identified and in consultation with the particular member of staff or as part of a wholesale refurbishment of this area.</p>	<p>Widen door openings and fit new doors sets to achieve min. 800mm clear width</p>	3R / 4	B

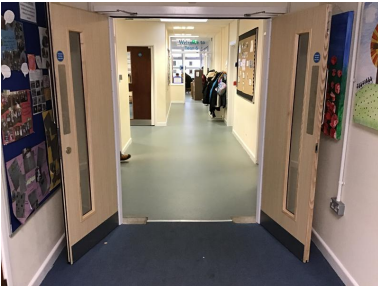
2.4.5	<p>Double compartment doors doors achieve a clear width of only 700mm through a single leaf.</p> <p>This will make them very difficult to operate by many wheelchair users, thus in the longer term we recommend that these double door sets are replaced with door and a half sets to achieve a minimum 800mm clear width through a single leaf.</p> <p>The doors are held open on magnetic catches linked to the fire alarm which mitigates this issue. They would still present a hazard in a means of escape situation.</p>	<p>Replace double doors with door and a half sets</p>	3R / 4	B

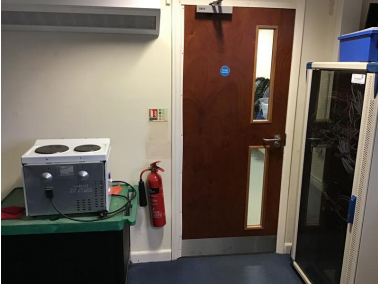
2.4.6	<p>The music room door achieves a clear width of 780mm.</p> <p>Best practice now recommends that all internal doors achieve a clear width of at least 800mm. Clear width is measured between door stop and the face of the door when held open.</p> <p>We consider the door to be within a reasonable margin of best practice standards and likely accessible by most wheelchair users. We find it unlikely it</p>	<p>Enlarge door to achieve a minimum 800mm clear width when next replacing the door sets</p>	3R / 4	Zero

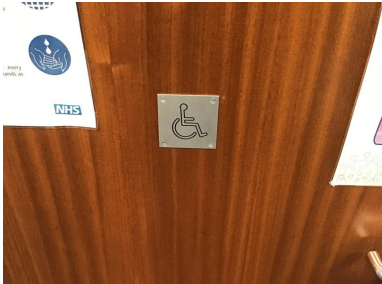
2.6.2.1	<p>The cubicle is poorly signed.</p> <p>It is important that disabled users can quickly locate an accessible toilet cubicle.</p>	Install additional signage to cubicle	2	A

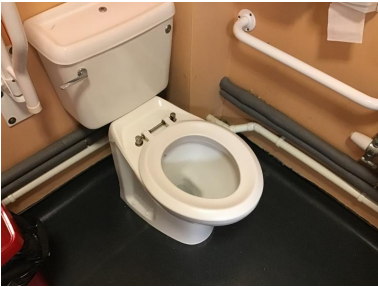
2.6.2.5	A well contrasted toilet seat makes the pan easier to locate by someone with a visual or mental impairment.	Fit new well contrasted toilet seat	2	A

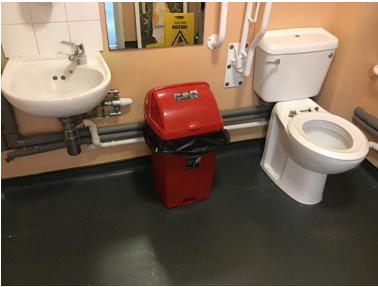
2.6.2.8	A bin is set in the lateral transfer zone to the side of the WC pan obstructing manoeuvring and transfer by a wheelchair user.	Move bin clear of transfer zone and instruct cleaners accordingly	1	Zero
<p>2.7 Accessible Changing Rooms</p>					
<p>2.7.1 A hygiene room is designed to provide pupils with more complex needs with a comfortable environment for assisting changing.</p>					
<p>The size of a hygiene room will vary according to the required changing need. In all cases, clinical wash hand basins are required for staff with drying facilities, storage is required for belongings, cleaning products and staff PPE, the cubicle should be fitted with a panic alarm.</p>					
<p>In a primary school or early years setting, a simple hygiene room with an assisted WC and changing table with space for a mobile hoist may be sufficient.</p>					
<p>Where a pupil has more complex care</p>

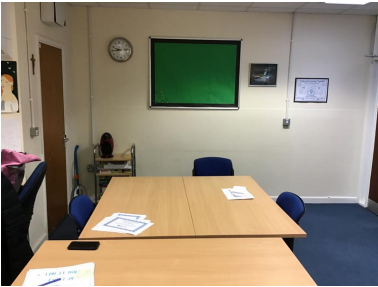
2.8.2	<p>Given the size of the larger meeting room it may prove difficult for a hearing aid user to listen to or hear a speaker.</p> <p>Thus we recommend that a hearing loop is fitted to this room to aid communication.</p>	Fit hearing loop to main meeting room	2	A
2.9	Assembly Halls

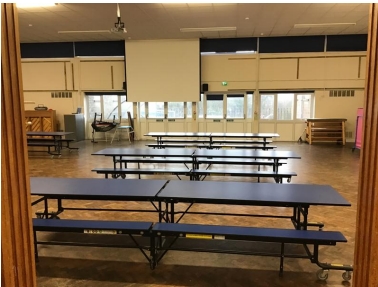
2.9.3	<p>Given the size of Hall it may prove difficult for a hearing aid user to listen to or hear a speaker.</p> <p>Thus we recommend that a hearing loop is fitted to this room to aid communication.</p> <p>As this issue is located in a public area of the building accessed by parents or visitors, we have given the issue a relatively high priority rating.</p>	Fit hearing loop to hall	2	B

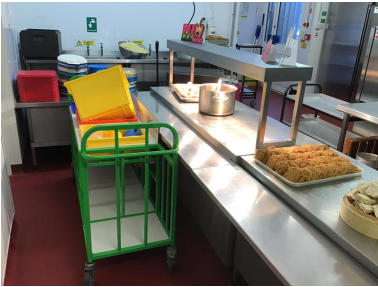
2.9.4	<p>The school hall is used as a dining area at lunchtimes.</p> <p>The dining hall operates on a self-service basis. This will pose a significant barrier to a wheelchair, crutch or frame user as carrying a tray and manoeuvring may prove very difficult.</p> <p>There is no practical adjustment to overcome this issue. Thus we recommend that staff are instructed to offer table service to disabled users as and when necessary.</p>	Train staff to offer table service and assistance when necessary	1	Zero

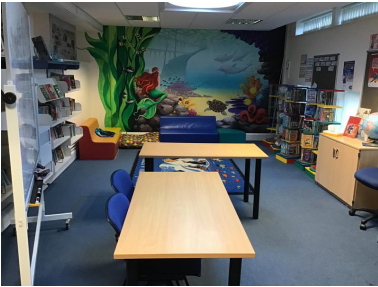
2.10.2	<p>Some shelves units are set over 1400mm above floor level, out of reach to most wheelchair users.</p> <p>We feel the only practical means of addressing this issue, is for staff to offer assistance as necessary.</p>	<p>Train staff to offer assistance to wheelchair users in accessing resources set on high shelves</p>	1	Zero

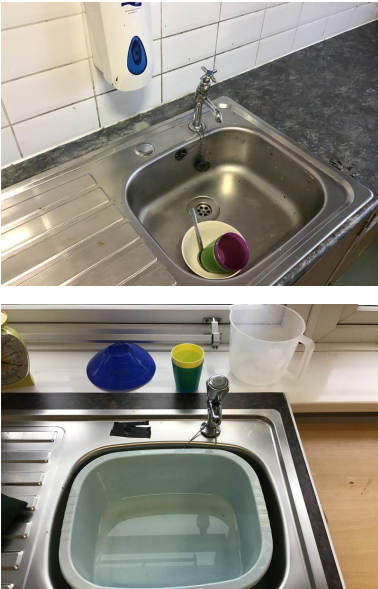
2.11.2	<p>Basins in the classrooms are fitted with knob type taps which will be difficult to grip and turn by someone with impaired dexterity to the hands.</p> <p>We recommend that all knob taps are replaced with lever type taps as part of ongoing maintenance /refurbishment or when a specific need is identified.</p> <p>As a minimum taps to accessible workstations should be fitted with lever type controls.</p>	Replace knob type taps with lever type taps	3R / 4	A

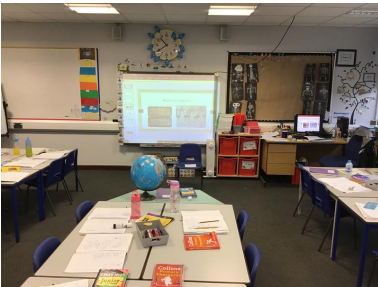
2.11.3	<p>Given the size of the classrooms it may prove difficult for a hearing aid user to listen to or hear a teacher or speaker.</p> <p>We recommend a fixed hearing loop is fitted to aid communication with hearing aid users. Teaching staff should be trained in its use and pictogram signage fitted to identify the loop.</p> <p>It would be appropriate to address this issue reactively when a specific need is identified.</p>	Fit hearing loop to classrooms	4	A

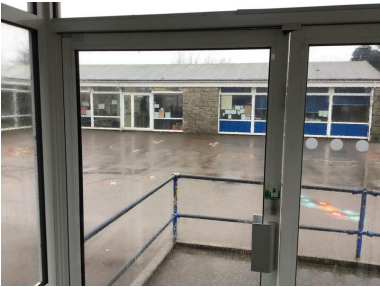
3.1.1.1	<p>The entrance doors require excessive force to pull open of more than 40Newtons, as a result it will prove difficult for a user with impaired upper body strength to open these doors.</p> <p>Best practice recommends a maximum opening force of 30Newtons for the first 30 degrees of the door swing and 22.5Newtons thereafter.</p>	<p>Adjust door closers to achieve maximum 30Newtons opening force</p>	3M	A

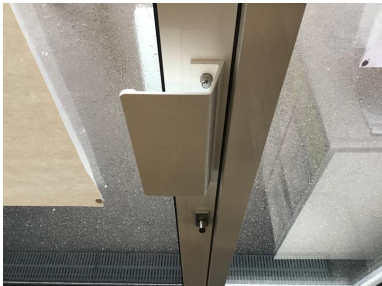
3.1.1.4	<p>The entrance door handles are poorly contrasted against the door frames making them difficult to identify by a visually impaired person.</p> <p>New handles should be of a lever, bar or 'D' handle type and aim to achieve a 30 point difference in light reflectance value with the frame. Knob handles should be avoided.</p>	<p>Fit new well contrasted door handles</p>	3R / 4	A

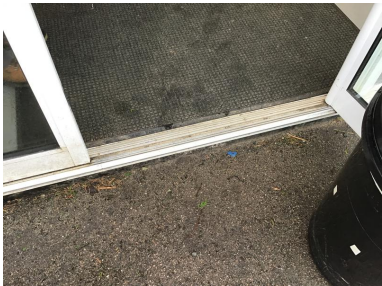
3.1.4.2	<p>The entrance door is stepped externally with an approximate level change of 150mm posing a barrier to a wheelchair user or those unable to manage steps.</p> <p>To avoid installing a ramp with handrails, the levels on the approach could be re-graded at a gradient of 1:21 or less in order to achieve a level threshold at the entrance door.</p> <p>As this issue is located in pupil only area of the building we see little justification for any adjustments in the short term unless required by a particular pupil.</p>	Re-grade external ground levels on the approach to the entrance door at a gradient of 1:21 or less in order to achieve a level threshold	3R / 4	B

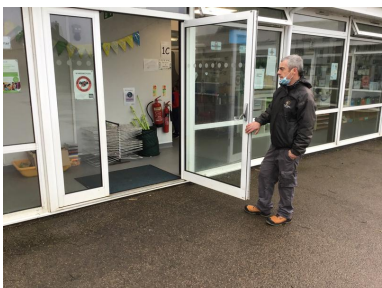
3.1.5 3.1.5.1	<p>Year 1 front entrance</p> <p>The entrance door is stepped externally with an approximate level change of 150mm posing a barrier to a wheelchair user or those unable to manage steps.</p> <p>To avoid installing a ramp with handrails, the levels on the approach could be re-graded at a gradient of 1:21 or less in order to achieve a level threshold at the entrance door.</p> <p>As this issue is located in pupil only area of the building we see little justification for</p>	Re-grade external ground levels on the approach to the entrance door at a gradient of 1:21 or less in order to achieve a level threshold	3R / 4	B

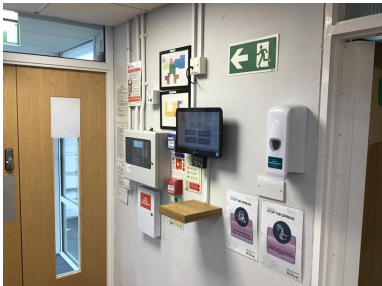
3.2.2	<p>The signing-in system is fitted at around 1700mm above floor level putting it out of reach of most wheelchair users.</p> <p>Best practice recommends that controls are installed within 1000-1200mm of floor level.</p>	<p>Lower touch screen so that all controls are within 1200mm of floor level</p>	2	A
<p>3.3 Horizontal Circulation</p>					
<p>3.3.1 General issues</p>
