Access Audit

St Michael's Primary School,
Penberthy Road, Helston TR13
8AR

Prepared on Behalf of
Celtic Cross Education (St Austell)

Date: 28th February 2022

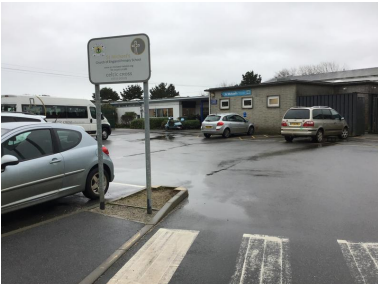
1.1.2	<p>The entrance signage has grey text which lacks tonal contrast against the grey back ground.</p> <p>Clear well contrasting signage is provided along the route to Infant and Junior Blocks.</p>	Provide new well contrasting entrance signage	3R	A

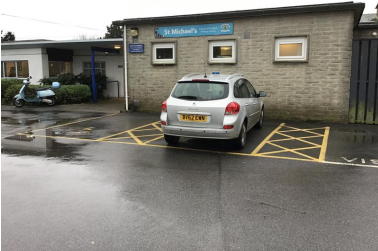
1.1.6	<p>The accessible bays do not have transfer zones to the rear. This may make it difficult for a wheelchair user to transfer from car to chair and vice versa.</p> <p>You should aim to achieve minimum 1200mm wide transfer zones to either side and the rear of all accessible bays.</p>	<p>Re-mark accessible bays with transfer zones to the rear</p>	3R	A

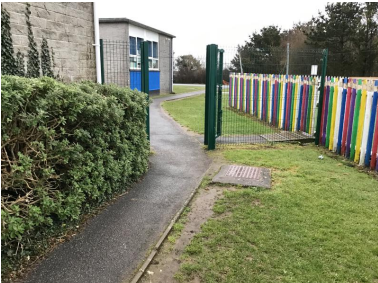
1.1.8	<p>The footpath does narrow to 900mm to the rear making it difficult to pass by a wheelchair user.</p> <p>This is a key route and there is scope to widen it in the longer term.</p>	<p>Widen footpath to achieve minimum 1200mm clear width</p>	3R / 4	B

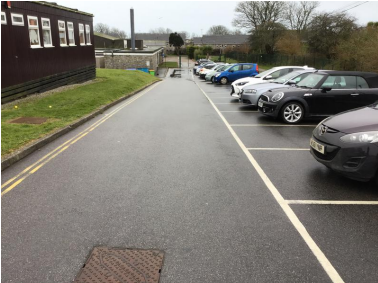
1.1.9	<p>The approach from the site entrance to Infant School building is set at a gradient exceeding 1:20 which will make it very difficult to negotiate by a manual wheelchair user in particular.</p> <p>However as the gradient is consistent with surrounding ground levels there is little practical alteration other than to make users aware in advance and advise of alternative routes at the rear.</p>	<p>Inform users of steep approach in advance i.e. website, access guide etc</p>	2	Zero

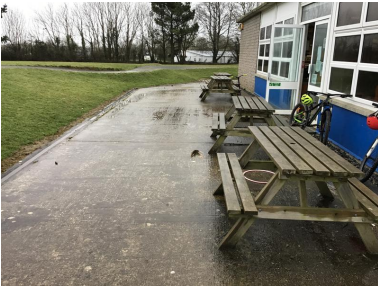
1.1.13	Benches are poorly contrasted against their background making them more difficult to discern by a visually impaired user posing a risk of collision.	Improve contrast of outdoor seating when redecorating	3R / 4	Zero

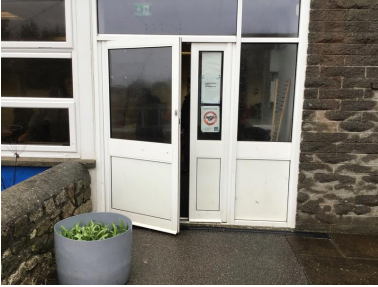
2.1.5.2	The plant pot obstructs manoeuvring space on the approach.	Relocate plant pot	1	Zero

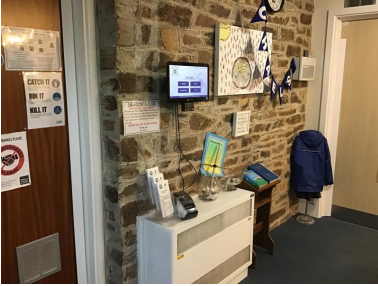
2.2.4	<p>The signing-in system is fitted at around 1600mm above floor level putting it out of reach of most wheelchair users.</p> <p>Best practice recommends that controls are installed within 1000-1200mm of floor level.</p>	<p>Lower touch screen so that all controls are within 1200mm of floor level</p>	2	A

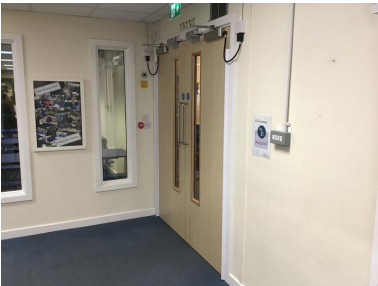
2.4.1.3	<p>Internal doors with a light veneered finish are poorly contrasted against wall surfaces making the openings difficult to identify by a visually impaired person.</p> <p>This can be addressed by painting the walls, architraves or doors in a contrasting colour.</p>	<p>Improve contrast of veneered doors door openings</p>	3R	Zero

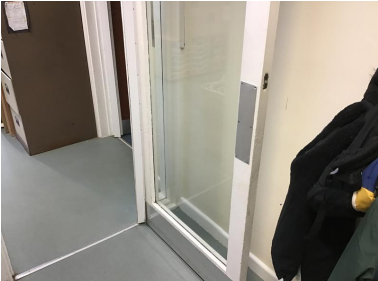
2.4.1.5	<p>A 30 point difference in light reflectance values of adjacent surfaces should be achieved. These values are readily available from paint suppliers.</p> <p>The glazed classroom doors are poorly manifested making them difficult to identify by a visually impaired user, putting him or her at risk of collision.</p> <p>Manifestation should be solid colour and be set at around 1500mm above floor level.</p>	Apply manifestation to classroom doors	2	A

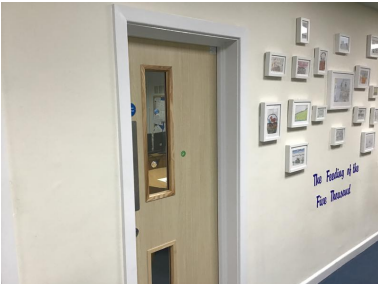
2.4.3	<p>The head teachers office door achieve a clear width of only 700mm making them difficult to pass by the majority of wheelchair users.</p> <p>Best practice now recommends that all internal doors achieve a clear width of at least 800mm. Clear width is measured</p>	<p>Widen head teacher office door openings and fit new doors sets to achieve min. 800mm clear width</p>	2	B

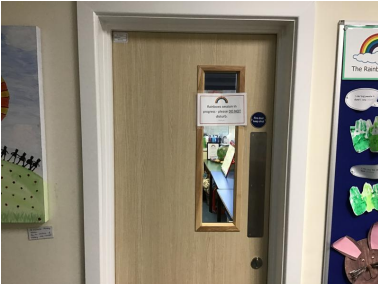
2.4.4	<p>between door stop and the face of the door when held open.</p> <p>As this issue is located in a public area of the building accessed by parents or visitors, we have given the issue a relatively high priority rating.</p> <p>The rainbow teaching support room achieve a clear width of only 700mm making them difficult to pass by the majority of wheelchair users.</p> <p>Best practice now recommends that all internal doors achieve a clear width of at least 800mm. Clear width is measured between door stop and the face of the door when held open.</p> <p>As this issue is located in pupil only area of the building we see little justification for any adjustments in the short term unless required by a particular pupil.</p> <p>It would be appropriate to undertake adjustments when a specific need is identified in consultation with the particular pupil or as part of a wholesale refurbishment of this area.</p>	<p>Widen rainbow door openings and fit new doors sets to achieve min. 800mm clear width</p>	3R / 4	B

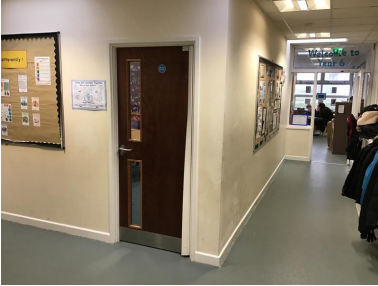
2.4.7	<p>would be considered reasonable to widen the door in the short term and suggest this issue be addressed when next replacing the door sets.</p> <p>The meeting room door achieve a clear width of 780mm.</p> <p>Best practice now recommends that all internal doors achieve a clear width of at least 800mm. Clear width is measured between door stop and the face of the door when held open.</p> <p>We consider the door to be within a reasonable margin of best practice standards and likely accessible by most wheelchair users. We find it unlikely it would be considered reasonable to widen the door in the short term and suggest this issue be addressed when next replacing the door sets.</p>	<p>Enlarge door to achieve a minimum 800mm clear width when next replacing the door sets</p>	3R / 4	Zero

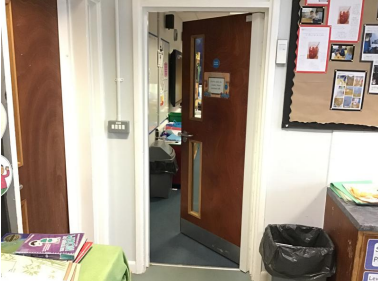
2.4.8	<p>Older Classroom doors achieve a clear width of 780mm.</p> <p>Best practice now recommends that all internal doors achieve a clear width of at least 800mm. Clear width is measured between door stop and the face of the door when held open.</p>	<p>Enlarge doors to achieve a minimum 800mm clear width when next replacing the door sets</p>	3R / 4	Zero

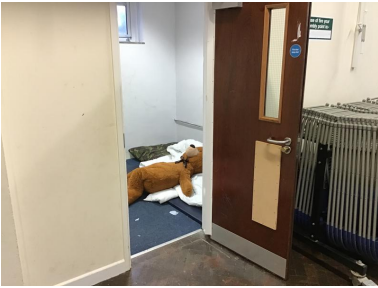
2.4.9	<p>We consider the doors to be within a reasonable margin of best practice standards and likely accessible by most wheelchair users. We find it unlikely it would be considered reasonable to widen the doors in the short term and suggest this issue be addressed when next replacing the door sets.</p> <p>As this issue is located in pupil only area of the building we see little justification for any adjustments in the short term unless required by a particular pupil.</p>	<p>Widen sensory room door openings and fit new doors sets to achieve min. 800mm clear width</p>	3R / 4	B
	<p>Best practice now recommends that all internal doors achieve a clear width of at least 800mm. Clear width is measured between door stop and the face of the door when held open.</p>	2.5 Standard Toilets	2.5.1 General issues	2.5.1.1 Our inspection was completed by an unaccompanied male surveyor so we did not access ladies toilets.

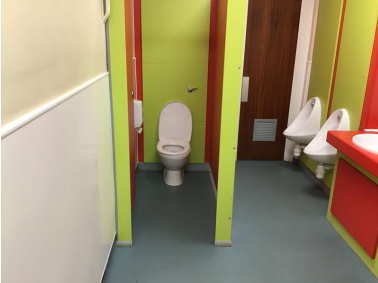
2.5.1.2	<p>However we assume that these are fitted out in a similar manner so you should assume our recommendations apply to both male and female areas.</p> <p>Where multiple cubicles are provided to standard toilets it presents best practice to install an ambulant cubicle for people with ambulant mobility impairments. None are provided here.</p> <p>Ambulant cubicles are slightly larger than standard and incorporate an outward opening door and grab rails to either side of the pan.</p> <p>As this issue is located in pupil only area of the building we see little justification for any adjustments in the short term unless required by a particular pupil.</p> <p>It would be appropriate to undertake adjustments when a specific need is identified in consultation with the particular pupil or as part of a wholesale refurbishment of this area.</p>	<p>Provide pupil ambulant accessible toilet with age appropriate sanitaryware, grab-rails and fittings</p>	3R / 4	B

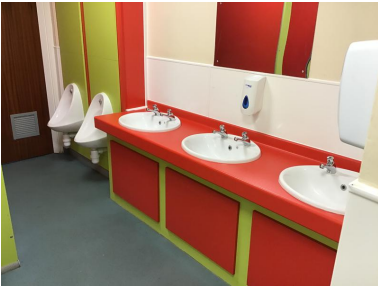
2.5.2.1	<p>The toilets are generally well designed. The lighting levels are adequate.</p> <p>The toilets are fitted with ergonomic brassware and fittings which will be easy to use by all.</p> <p>The sanitaryware and brassware achieve adequate colour and contrast against adjacent surfaces.</p>

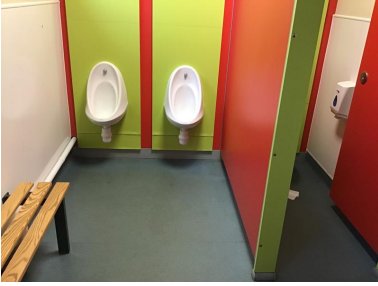
2.5.3.1	<p>The toilets are generally well designed. The lighting levels are adequate.</p> <p>The toilets are fitted with ergonomic brassware and fittings which will be easy to use by all.</p> <p>The sanitaryware and brassware achieve adequate colour and contrast against adjacent surfaces.</p>			
	2.5.4	Year 4 toilets

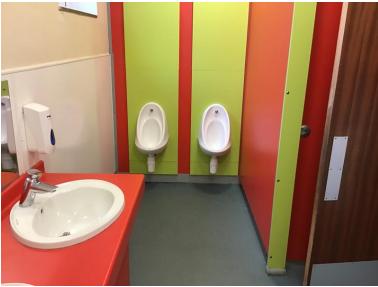
2.5.4.1	<p>The toilets are generally well designed. The lighting levels are adequate.</p> <p>The toilets are fitted with ergonomic brassware and fittings which will be easy to use by all.</p> <p>The sanitaryware and brassware achieve adequate colour and contrast against adjacent surfaces.</p>

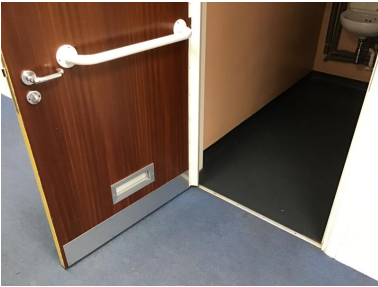
2.6.2.2	The cubicle door achieves a clear width of around 870mm which should be adequate for all users.

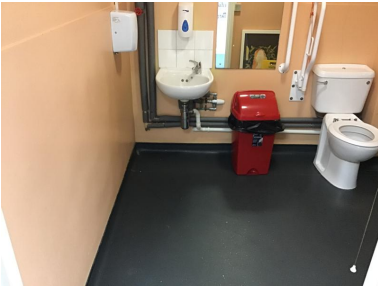
2.6.2.3	The cubicle achieves clear dimensions of 2200mm deep by 2200mm wide which is in excess of current best practice guidelines.

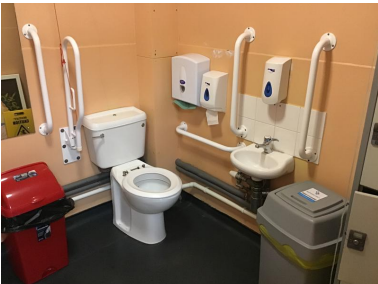
2.6.2.4	The cubicle is set out in a corner layout designed for independent use. It is generally well detailed and should prove accessible to most users.

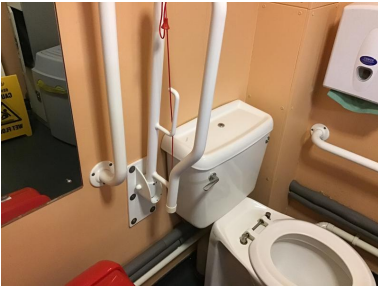
A pull cord alarm is fitted in the Junior School accessible toilet but the cord does not extend to floor level putting it out of reach to someone who has fallen onto the floor.

2.6.2.6	A pull cord alarm is fitted but the cord does not extend to floor level putting it out of reach to someone who has fallen onto the floor.	Extend alarm cord to within 100mm of floor level	1	Zero

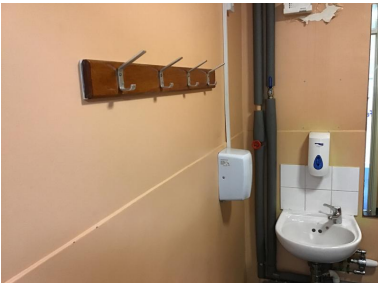
2.6.2.7	Coat hooks are set out of reach of most wheelchair users.	Fit coat hook at 1050mm above floor level	2	A

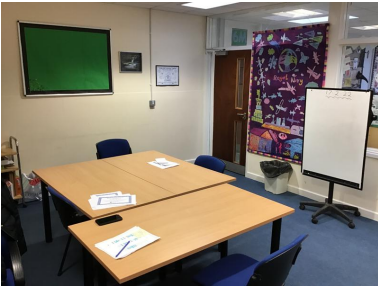
2.8.1	<p>Subject to the arrangement of loose furniture, the principal meeting room generally achieves adequate circulation space in order that a wheelchair user can enter, turn and attend a meeting.</p> <p>We assume that the layout of loose furniture is set out to suit the specific attendees and can be adjusted as and when necessary.</p> <p>Lighting levels are adequate achieving 300lux min at the table level.</p>

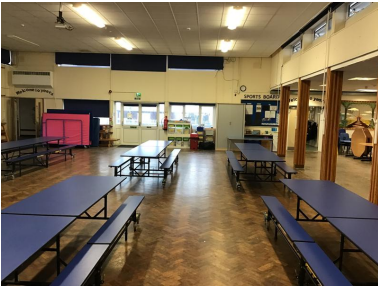
2.9.1	<p>The school hall is an open plan space which subject to the arrangement of loose furniture and equipment will be accessible to all users.</p>

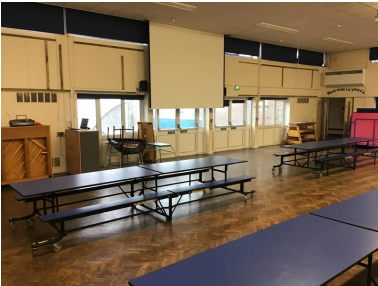
2.9.2	<p>Lighting levels in the hall are generally adequate with lux levels at the desk surface of 400lux which exceeds current best practice.</p>

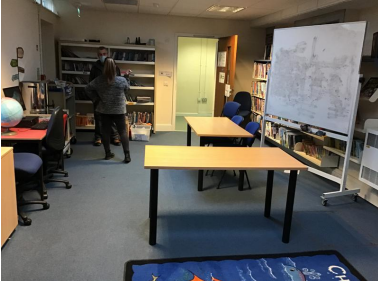
2.10	Library			
	2.10.1	<p>The Library is of an adequate size and achieves adequate manoeuvring space for a pupil with a mobility aid or wheelchair to access some or all of the space and resources, subject to the layout of loose furniture.</p>

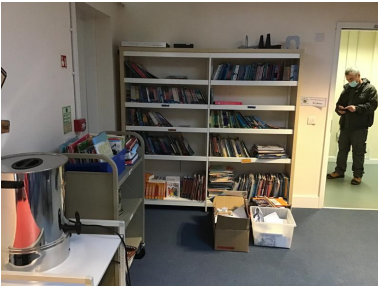
2.10.3	<p>Lighting levels in the Library are inadequate with lux levels at the desk surface as low as 60lux.</p> <p>We recommend that the lighting is upgraded to achieve a minimum of 300lux at the desk surface.</p>	<p>Upgrade light levels to achieve a minimum of 300lux at the desk surface</p>	2	A
<p>2.11 Classrooms</p>

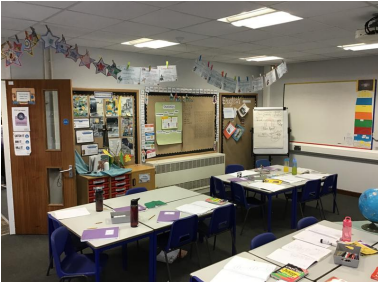
2.11.1	<p>The classrooms are generally of an adequate size and achieve adequate manoeuvring space for a pupil with a mobility aid or wheelchair to access some or all of the space and classroom resources, subject to the layout of loose furniture.</p>

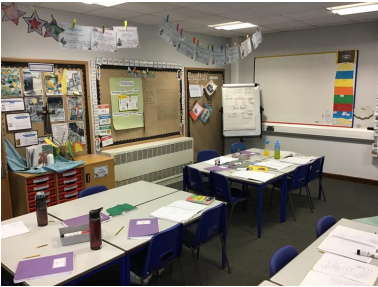
2.11.4	<p>Lighting levels in the classrooms are generally adequate with lux levels at the desk surface of 400lux which exceeds current best practice.</p>			
	2.12	Offices			
	2.12.1	<p>The heads office space is generally well detailed achieving adequate manouvering space with good lights levels at the desk surface in excess of 300lux.</p> <p>This will allow all parents access to the head teacher.</p>			
	2.13	Signage and Wayfinding

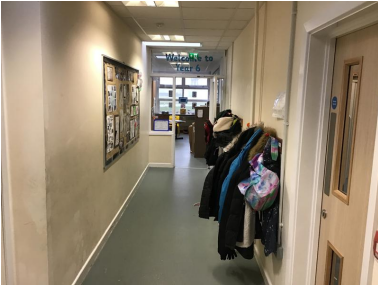
2.13.1	<p>The school has limited internal wayfinding signage.</p> <p>This reflects the staff and pupils familiarity with the layout of the school. Visitors to the school are accompanied by staff.</p> <p>Considering the above and the relatively small size of the school, we see little</p>

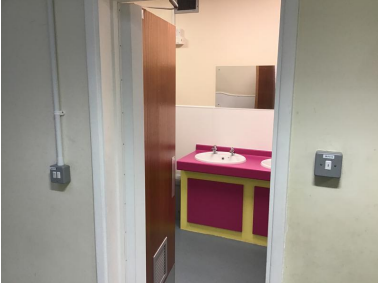
2.13.2	<p>justification for additional wayfinding signage.</p> <p>We do recommend that signage is fitted to identify key facilities such as toilets.</p>	Fit new signage to identify key facilities	2	A
2.14 Means of Escape

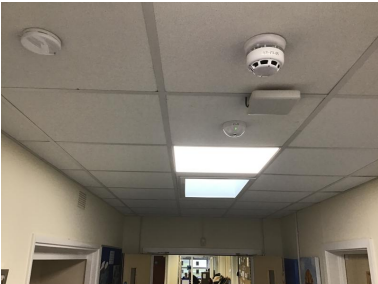
2.14.1	We are pleased to note that the fire alarm system appears to be fitted with combined sounder and beacons heads throughout so ensuring a deaf user is alerted in the event of fire.

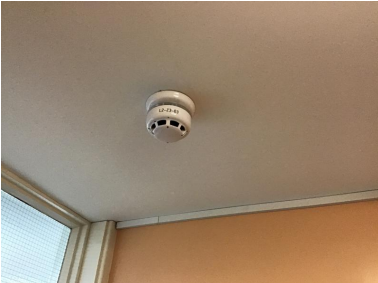
2.14.2	We are pleased to note that accessible toilets appear to be fitted with beacons linked to the fire alarm to give additional warning to a hearing impaired user.

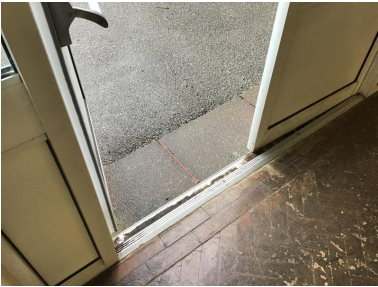
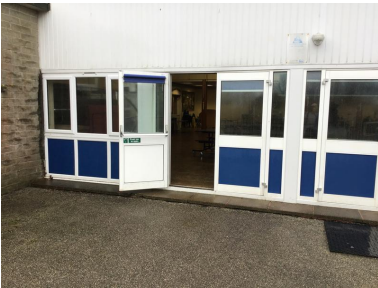
2.14.5	<p>authority but many fire authorities publish their guidance online so it is readily available.</p> <p>The final exit doors to the School Hall are stepped externally.</p> <p>This will prevent an independent means of escape.</p> <p>From external ground level to internal finished floor level, the level change is approx. 150mm.</p> <p>Rather than fit a ramp with a level landing and handrail, we recommend external ground levels are re-graded at 1:21 or less to achieve a level threshold detail.</p>	Re-grade external ground levels at 1:21 or less to achieve a level threshold.	2	B
	3.0	Infant Building			
	3.1	Entrances			
	3.1.1	General issues

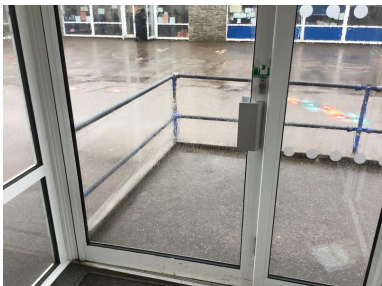
3.1.1.4	<p>The entrance door handles are poorly contrasted against the door frames making them difficult to identify by a visually impaired person.</p> <p>New handles should be of a lever, bar or 'D' handle type and aim to achieve a 30 point difference in light reflectance value with the frame. Knob handles should be avoided.</p>	<p>Fit new well contrasted door handles</p>	3R / 4	A

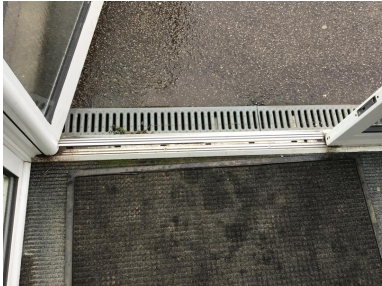
3.1.2.1	<p>The entrance door achieves a clear width of 1050mm which exceeds current best practice standards so should be sufficient for all.</p>

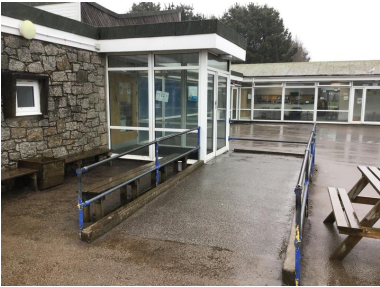
3.1.2.3	The ramp to the staff and hall entrance is generally well detailed achieving a suitable gradient with ergonomic handrails to either side, a reasonable width and what appears to be adequate lighting.

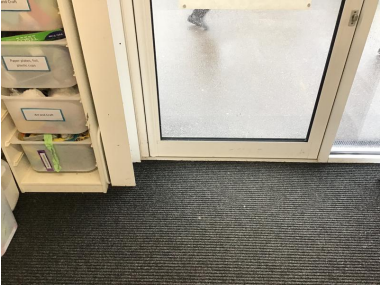
3.1.3	Year 2 rear entrance			
	3.1.3.1	The entrance doors achieve a clear width of at least 1000mm which exceeds current best practice standards so should be sufficient for all.

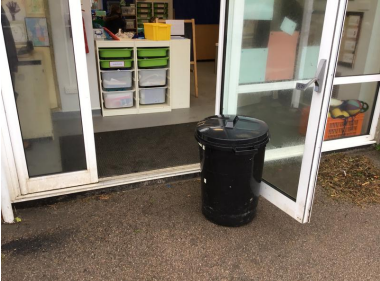
3.1.4	Year 2 front entrance			
	3.1.4.1	The entrance doors achieve a clear width of at least 1000mm which exceeds current best practice standards so should be sufficient for all.

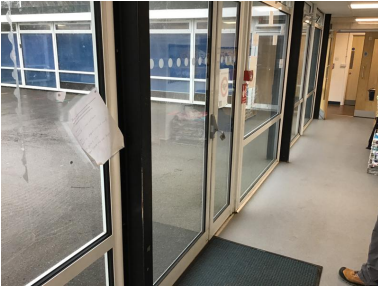
3.1.5 3.1.5.1	<p>Year 1 front entrance</p> <p>The entrance door is stepped externally with an approximate level change of 150mm posing a barrier to a wheelchair user or those unable to manage steps.</p> <p>To avoid installing a ramp with handrails, the levels on the approach could be re-graded at a gradient of 1:21 or less in order to achieve a level threshold at the entrance door.</p> <p>As this issue is located in pupil only area of the building we see little justification for</p>	Re-grade external ground levels on the approach to the entrance door at a gradient of 1:21 or less in order to achieve a level threshold	3R / 4	B

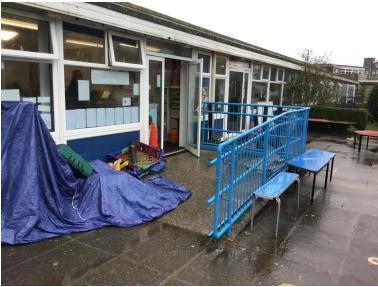
3.1.6 3.1.6.1	<p>Year 1 rear entrance</p> <p>The entrance door is stepped externally with an approximate level change of 250mm posing a barrier to a wheelchair user or those unable to manage steps.</p> <p>In this instance the adjoining Year 1 classroom has a ramp. We therefore see little justification for adjustments in the short term. This issue could be dealt with by allocation of classrooms.</p>

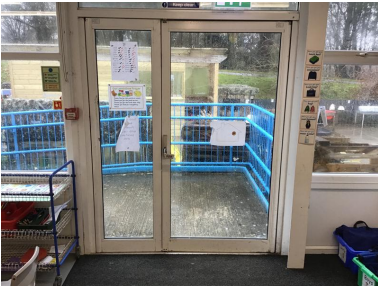
3.1.7.2	The entrance door is stepped externally with an approximate level change of 200mm posing a barrier to a wheelchair user or those unable to manage steps.			
		In this instance the adjoining reception class has a ramp. We therefore see little justification for adjustments in the short term.			
	3.1.8	Second reception entrance

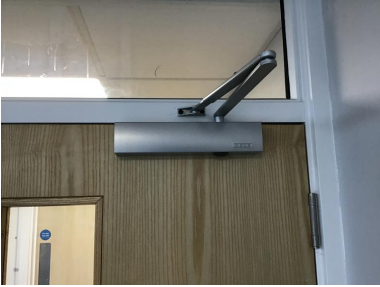
3.4.1.1	<p>We tested a sample of the internal doors and found that, where fitted with self-closing devices, they generally require excessive force to pull open of more than 40Newtons making them difficult to open by a user with impaired upper body strength.</p> <p>Best practice recommends a maximum opening force of 30Newtons for the first 30 degrees of the door swing and 22.5Newtons thereafter.</p>	<p>Adjust self-closing devices to achieve maximum 30 Newtons opening force to internal doors</p>	3M	A

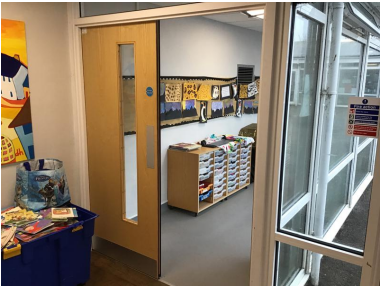
3.4.2	<p>Double compartment doors achieve a clear width of only 760mm through a single leaf.</p> <p>This will make them very difficult to operate by many wheelchair users, thus in the longer term we recommend that these double door sets are replaced with door and a half sets to achieve a minimum 800mm clear width through a single leaf.</p> <p>We consider the doors to be within a reasonable margin of best practice standards and likely accessible by most wheelchair users. We find it unlikely it would be considered reasonable to widen the doors in the short term and suggest this issue be addressed when next replacing the door sets.</p>	<p>Enlarge doors to achieve a minimum 800mm clear width when next replacing the door sets</p>	3R / 4	Zero

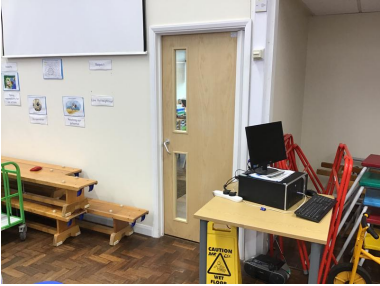
3.4.3	<p>The 1-2-1 room doors achieve a clear width of 780mm.</p> <p>Best practice now recommends that all internal doors achieve a clear width of at least 800mm. Clear width is measured between door stop and the face of the door when held open.</p> <p>As this issue is located in pupil only area</p>	<p>Enlarge door to achieve a minimum 800mm clear width when next replacing the door sets</p>	3R / 4	Zero

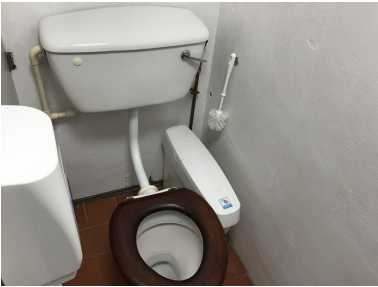
3.5.4.3	<p>The sanitaryware and fittings are poorly contrasted making them difficult to identify by a visually impaired user.</p> <p>This should be addressed when next refurbishing this area.</p>	<p>Improve contrast of sanitaryware and fittings</p>	3R	Zero

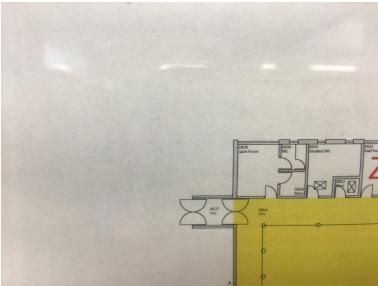
3.5.4.4	<p>The staff toilets are currently accessed directly from the Woodland 1-2-1 teaching and medical room.</p> <p>We do not consider this arrangement appropriate. We recommend that the staff toilets are relocated.</p> <p>By converting the adjacent store access to staff toilets could be provided from the entrance area and main hall.</p>	<p>Relocate staff toilets</p>	2	D

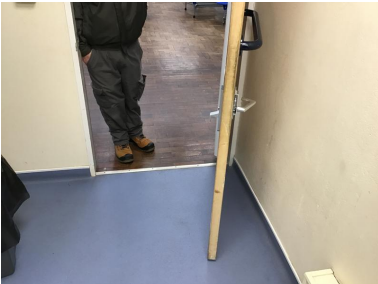
<p>3.6.2.1 The cubicle door opens inwards and thus there is a risk of the door becoming blocked if a user falls against it.</p>	<p>In this instance it is practical to simply re-hang the door to open outwards.</p>	<p>Re-hang door to open outwards</p>	<p>2</p>	<p>A</p>

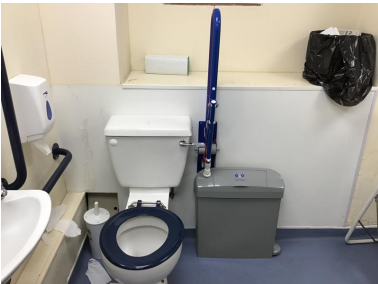
3.6.2.4	An additional vertical grab rail should be fitted to the WC pan.	Fit additional vertical grab rail	2	A

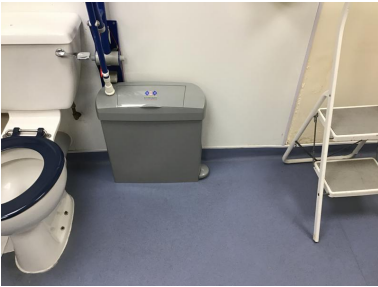
3.6.2.5	A bin is set in the lateral transfer zone to the side of the WC pan obstructing manoeuvring and transfer by a wheelchair user.	Move bin clear of transfer zone and instruct cleaners accordingly	1	Zero

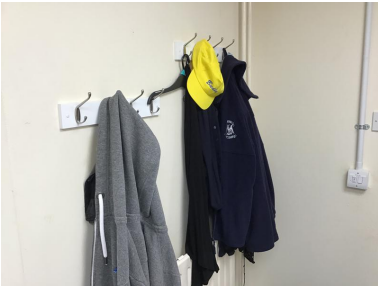
3.6.2.6	Coat hooks are set out of reach of most wheelchair users.	Fit coat hook at 1050mm above floor level	2	A

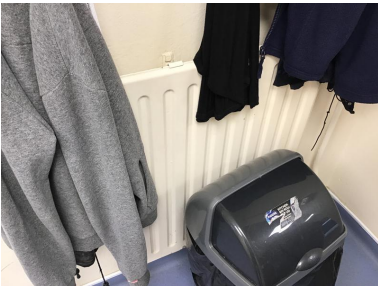
3.6.2.7	The radiator is not a low surface temperature unit so if a user falls against it there is a risk of burning.	Fit LST cover to radiator	2	A
<h3>3.7 Assembly Halls</h3>

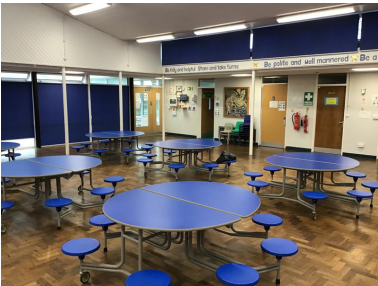
3.7.3	<p>Given the size of the hall, it will prove difficult for a hearing aid user to listen to or hear a teacher or speaker.</p> <p>We recommend a fixed hearing loop is fitted to aid communication with hearing aid users.</p> <p>Teaching staff should be trained in its use and pictogram signage fitted to identify the loop at the entrance.</p> <p>As parents and visitors will have access</p>	Fit hearing loop to hall and provide signage at entrance	2	B

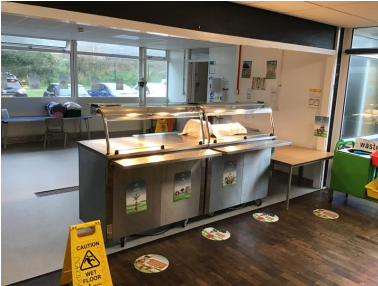
3.7.4	<p>to this area of the school, we recommend this issue is addressed in the short term.</p> <p>The school hall is used as a dining area at lunchtimes.</p> <p>The dining hall operates on a self-service basis. This will pose a significant barrier to a wheelchair, crutch or frame user as carrying a tray and manoeuvring may prove very difficult.</p> <p>There is no practical adjustment to overcome this issue. Thus we recommend that staff are instructed to offer table service to disabled users as and when necessary.</p>	Train staff to offer table service and assistance when necessary	1	Zero

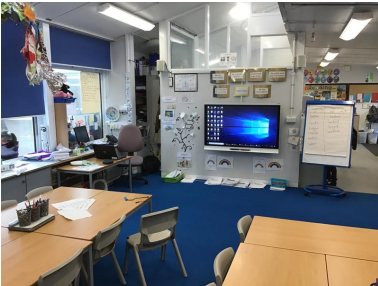
3.8.3	<p>Given the size of the classrooms it may prove difficult for a hearing aid user to listen to or hear a teacher or speaker.</p> <p>We recommend a fixed hearing loop is fitted to aid communication with hearing aid users. Teaching staff should be trained in its use and pictogram signage fitted to identify the loop.</p> <p>It would be appropriate to address this issue reactively when a specific need is identified.</p>	Fit hearing loop to classrooms	4	A
	3.9	Signage and Wayfinding			
	3.9.1	<p>The school has limited internal wayfinding signage.</p> <p>This reflects the staff and pupils familiarity with the layout of the school. Visitors to the school are accompanied by staff.</p>

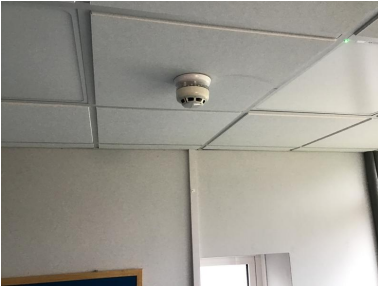
3.10.1	<p>We are pleased to note that the fire alarm system appears to be fitted with combined sounder and beacons heads throughout so ensuring a deaf user is alerted in the event of fire.</p>

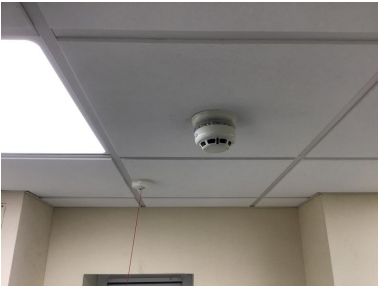
3.10.2	<p>We are pleased to note that all toilets appear to be fitted with beacons linked to the fire alarm to give additional warning to a hearing impaired user.</p> <p>Ideally this would extend throughout the building with all sirens supplemented with beacons or strobes.</p>

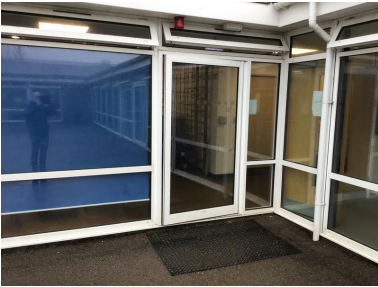
3.10.5	<p>The final exit door to the Hall is stepped externally.</p> <p>This will prevent an independent means of escape.</p> <p>From external ground level to internal finished floor level, the level change is approx. 150mm.</p> <p>We recommend that a ramp with a level landing and well contrasting handrail is fitted which will ensure an independent means of escape for all users.</p>	Fit a ramp with a level landing and well contrasting handrail.	2	B

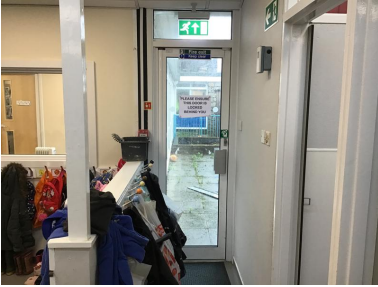
3.10.6	<p>The final exit door to the second reception classroom achieves a clear width of less than 600mm making it very difficult to pass by a wheelchair user.</p> <p>There are 2 alternative means of escape. We suggest that you review this strategy with your Fire Risk Assessor.</p>	Review escape route with Fire Risk Assessor	2 / EXP	A
<p>3.11 Accessible Changing Rooms</p>

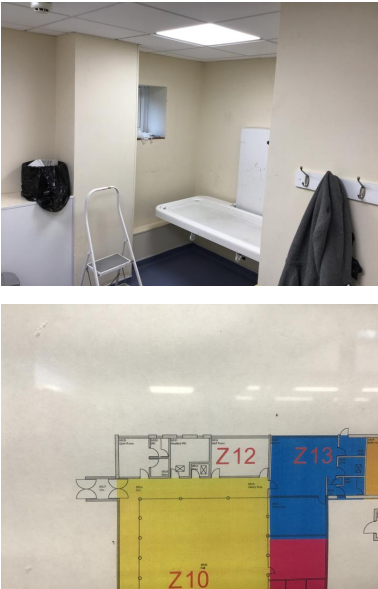
3.11.1	<p>The hygiene room or assisted changing cubicle achieves clear dimensions of 2200mm deep by 1800mm wide.</p> <p>The cubicle is accessed from and is combined with the staff and visitor accessible toilet. We do not consider this appropriate.</p> <p>We recommend that the assisted changing room is relocated.</p> <p>The existing staff toilet and store room in front of it and Woodland room could be remodelled to create a new hygiene room.</p>	Relocate hygiene room	2	E
<p>4.0 Generic Site Wide Issues</p>					
<p>4.1 Staff Training and Awareness</p>
